# Excavation of a Lime Kiln at Knowle Farm, Mellor

*A report by Donald Reid and John Roberts of the Mellor Archaeological Trust.*

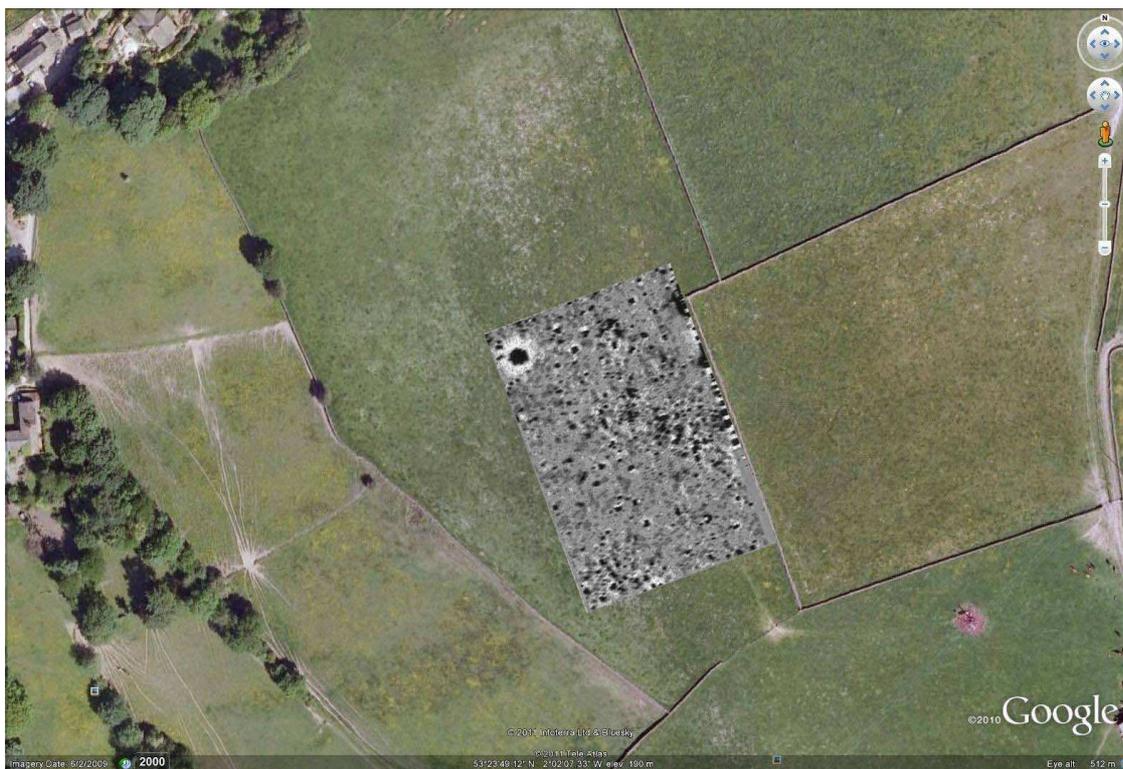
Figure 2. Modern aerial photograph with the results of the magnetometry survey superimposed.

Why; In August and September 2009 the Mellor Archaeological Trust conducted excavations in a field now known as Top Field belonging to Knowle Farm in Mellor (Grid reference: 397740, 388920). The excavation was part of a programme by the Trust and the Greater Manchester Archaeological Unit which sought to identify possible archaeological sights in the vicinity of the Iron Age remains located in the Old Vicarage garden half a mile to the east. Vital to this programme were the series of geophysical surveys carried out by the late Philip Day. 'Top Field' is the final step in a series of ridges which sees the land descend from the hilltop at the Old Vicarage to Marple Bridge. As such it seemed a likely possible location for prehistoric settlement and was targeted for geophysical survey. It was during the magnetometry survey of the field in July 2007 that an intense magnetic anomaly was detected. Ever the scientist Philip would not be drawn on the source of this anomaly stating '*Could be a large piece of metal buried in the ground, but could be an old pit, well, golf bunker....?*' adding '*All told, very interesting but needs a trench or two to see what we are looking at, if anything.*'

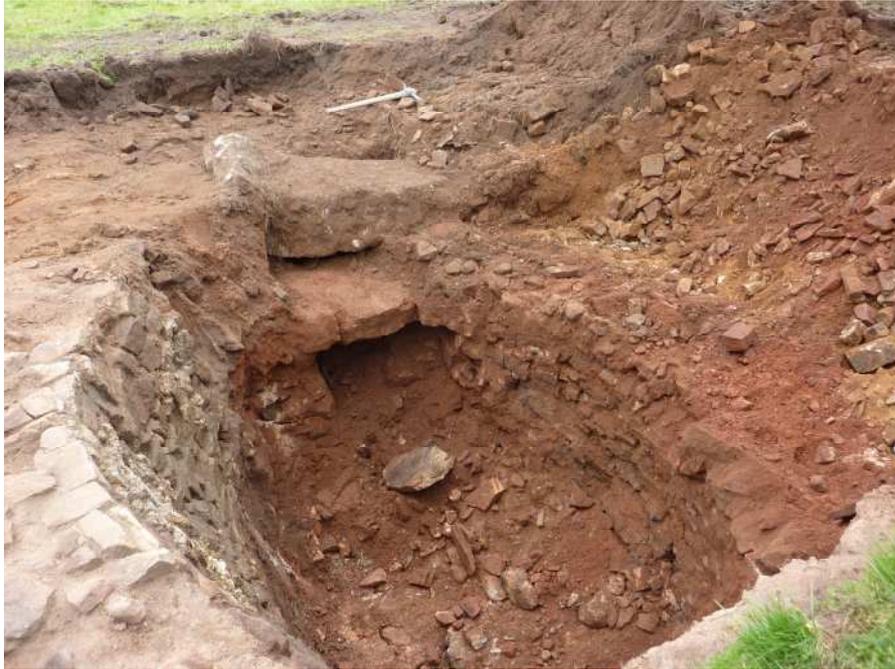
Figure 3. Initial machine excavation revealed the kiln 'Eye'.

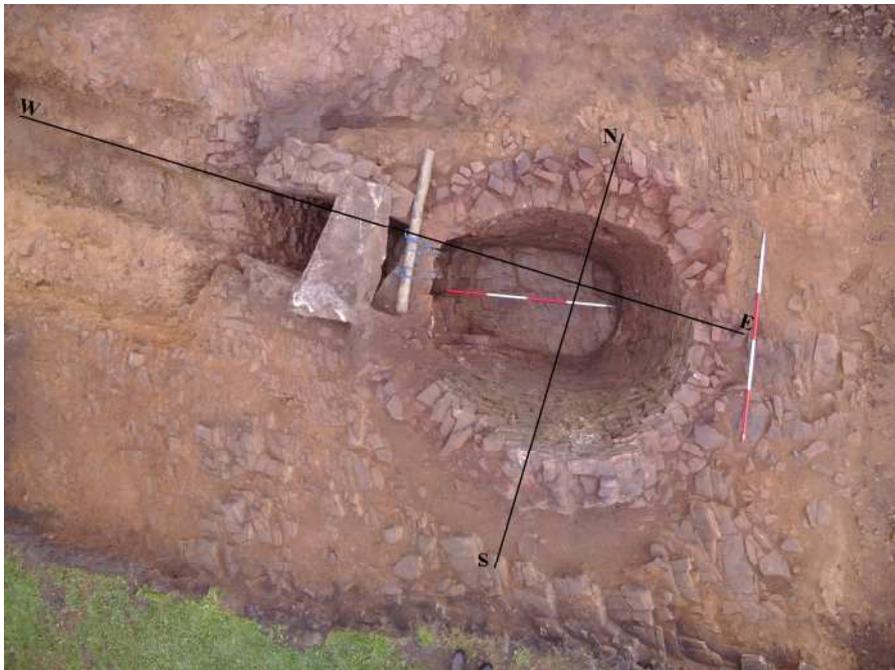
Figure 4 Overhead photograph showing the excavated structure and the lines of the drawn profile and elevation.

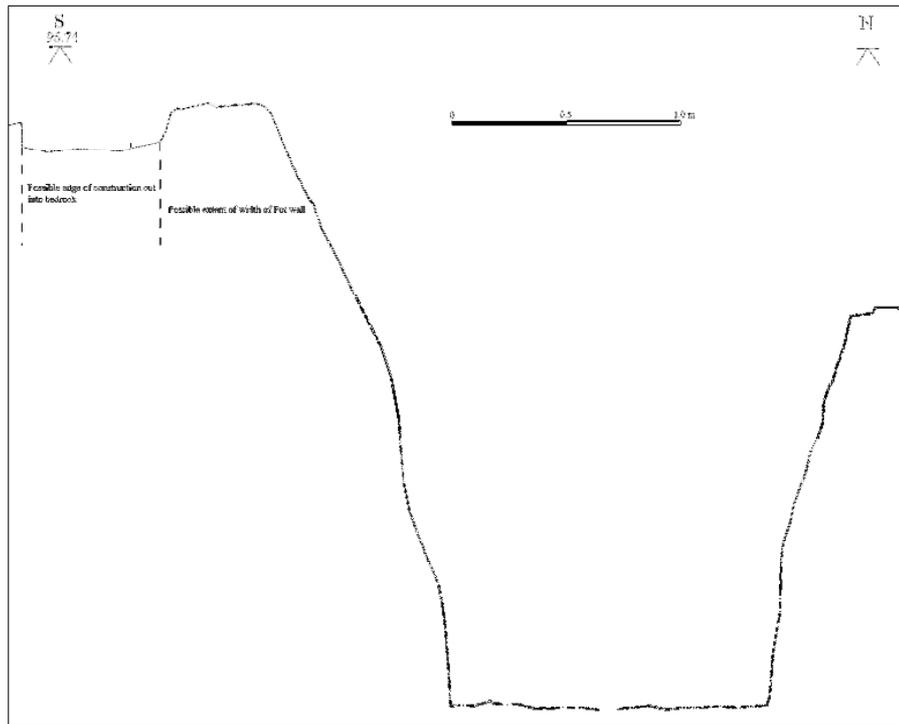
Figure 5. South to north profile of the Pot. N.B due to the remote location of the site the value of the temporary bench mark used for all readings was not tied in to an Ordnance Survey benchmark. All site readings are accurate relative to each other, the TBM is part of a solid wall and should it prove essential its Ordnance Datum height can be surveyed in.

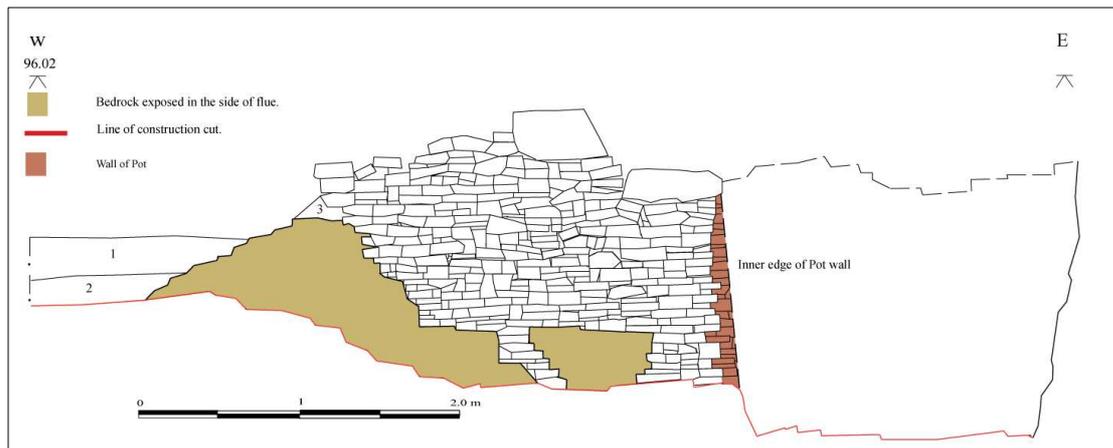
Figure 5. West to East elevation through the kiln.

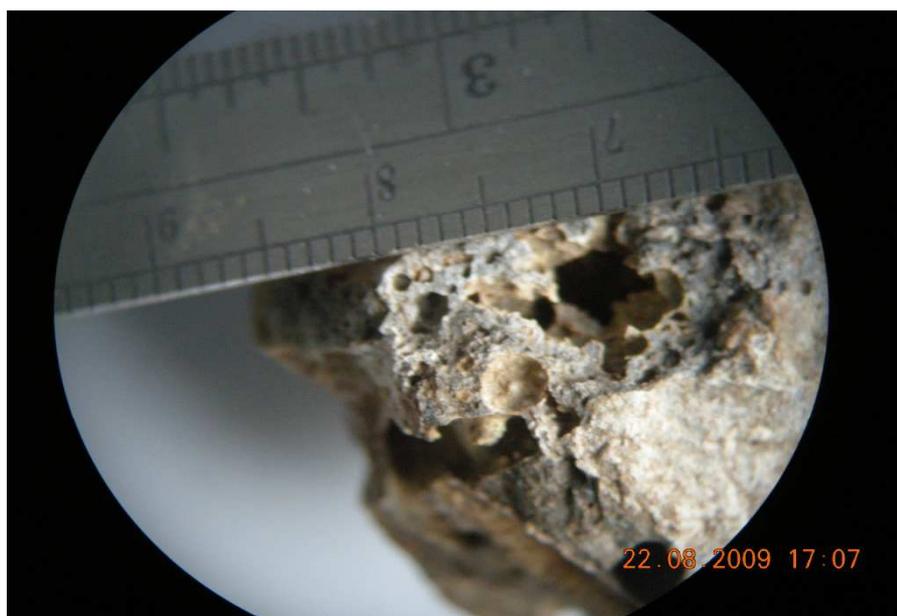
Figure 6. Photomicrograph of a small piece of the "white deposit on the south wall (cm scale). Note: looks like clinker or slag; heterogeneous nature of material; rounded nature of edges (probably due to melting); blowholes from escaping gas; the fact that parts of this deposit react with acid, indicating a carbonate.

Firstly an analysis by Philip Day of a sample of the deposit on the wall of the structure which 'looks like clinker or slag; heterogeneous nature of material; rounded nature of edges (probably due to melting); blowholes from escaping gas; the fact that parts of this deposit react with acid, indicating a carbonate'. The combination of heat and a possible residue of limestone are a compelling argument for the structure being a lime kiln.

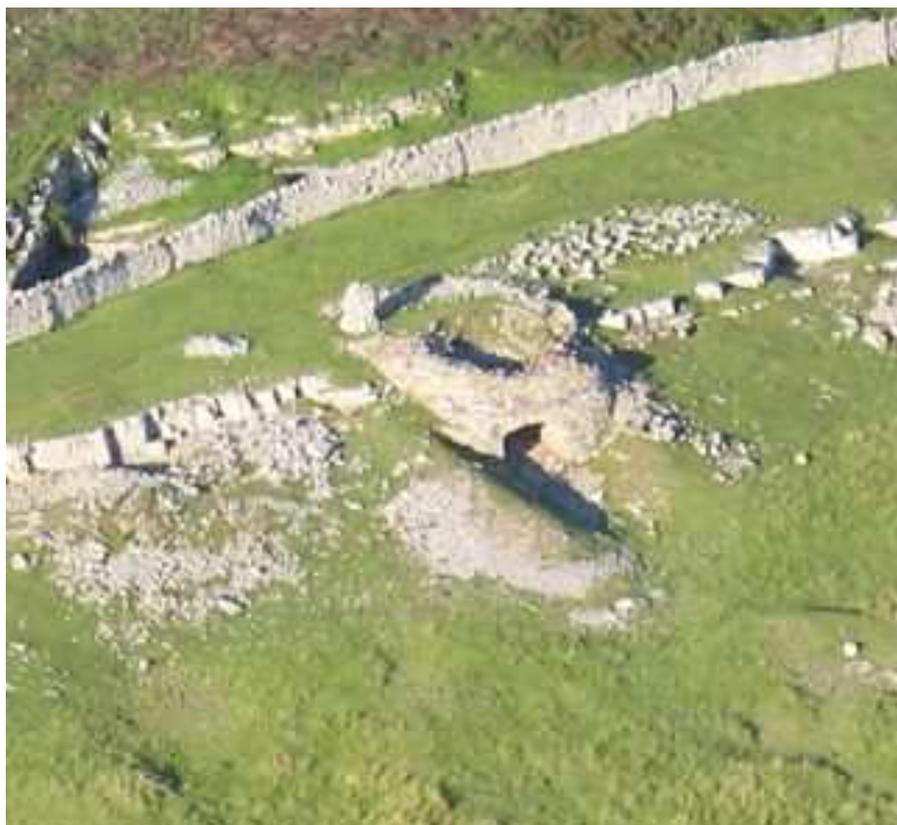
Figure 7. Field kiln at Ravenstonedale in Cumbria. Typically of these kilns it is constructed into the side of a slope.

The second body of evidence comes from a comparison of the remains with other sites. Typologically the remains excavated at Knowle Farm bare a striking resemblance to limekilns excavated elsewhere, particularly the solitary kilns of the northern uplands which utilise local stone and whenever possible are built into slopes.

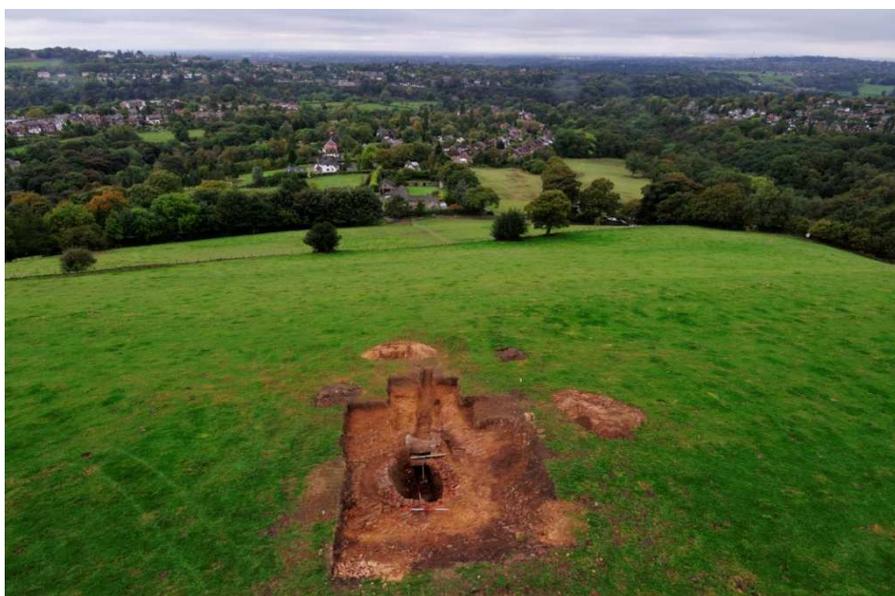
Figure 8. Photograph of the excavated kiln looking west, downhill, towards Townescliffe.

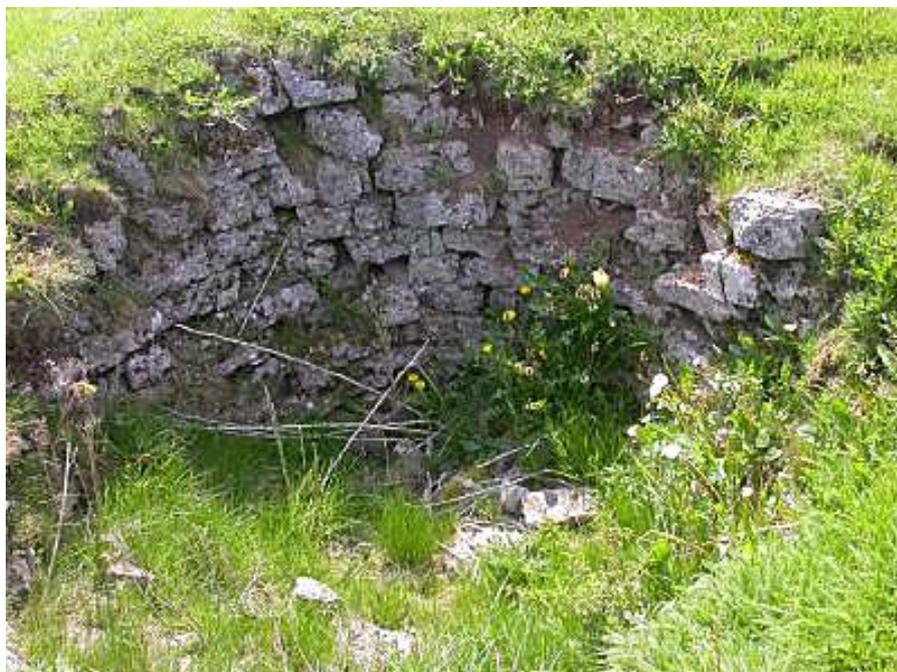
Figure 9. Partly infilled Pot of a field kiln in Monyash Derbyshire.

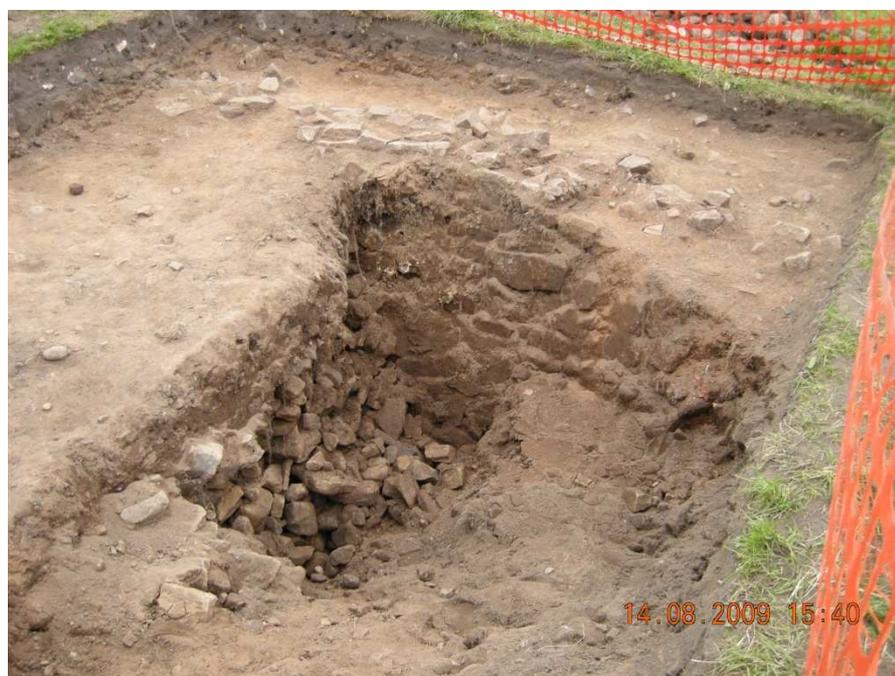
Figure 10. Partly excavated Pot during the evaluation. Looking South.

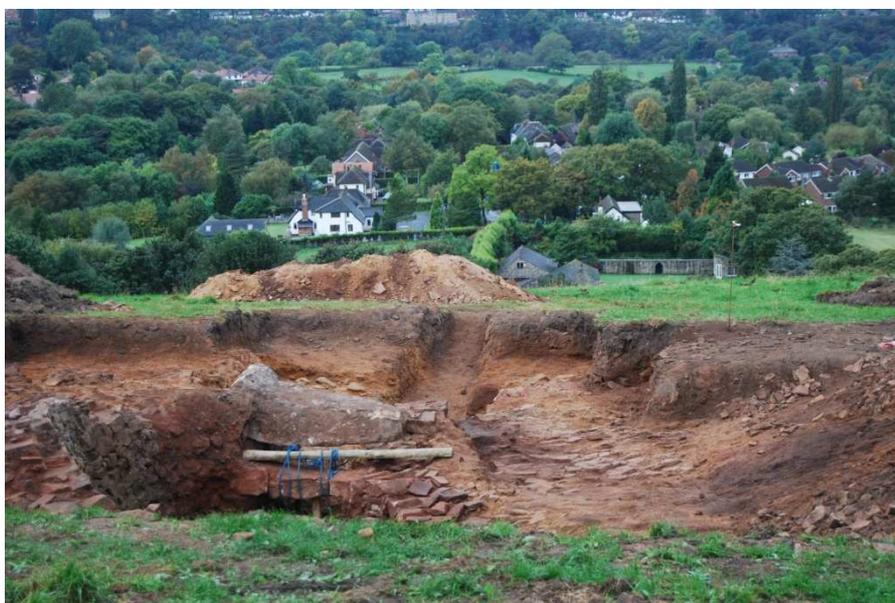
Figure 12. A view looking west giving an indication of the slope into which the structure was built.

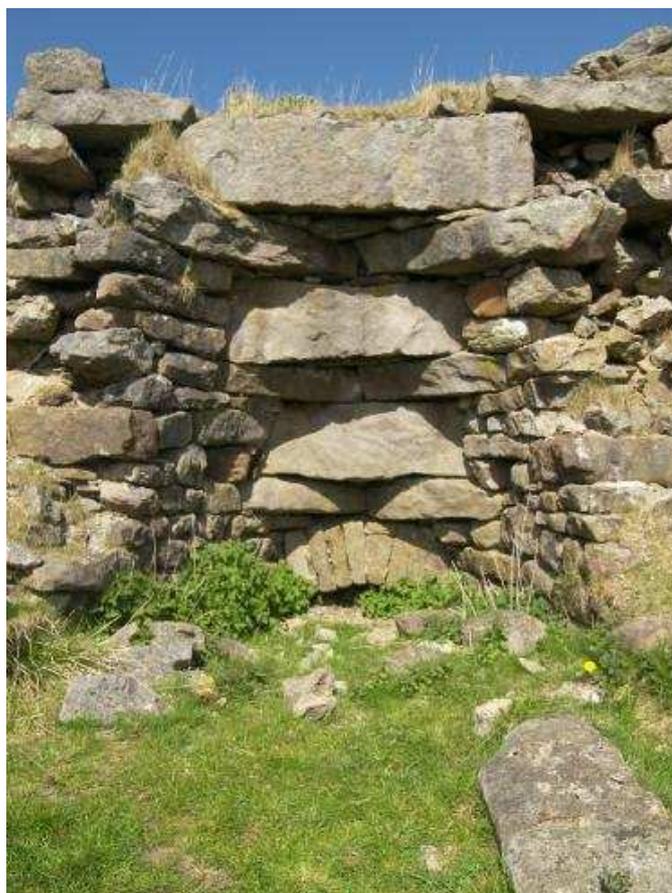
Figure 12. Field kiln in South Bowland showing staggered lintels above the arch of the flue.

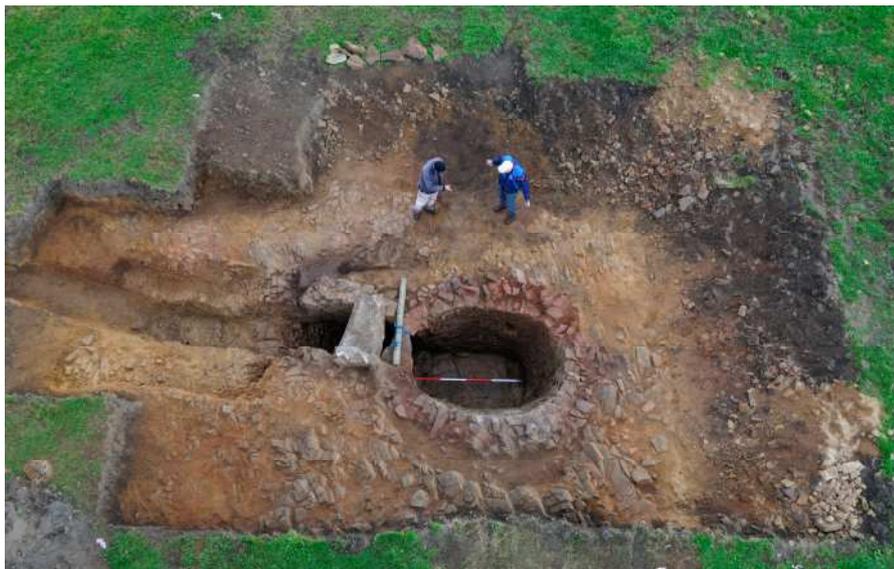
Figure 14 Photograph of the completed excavation looking north.

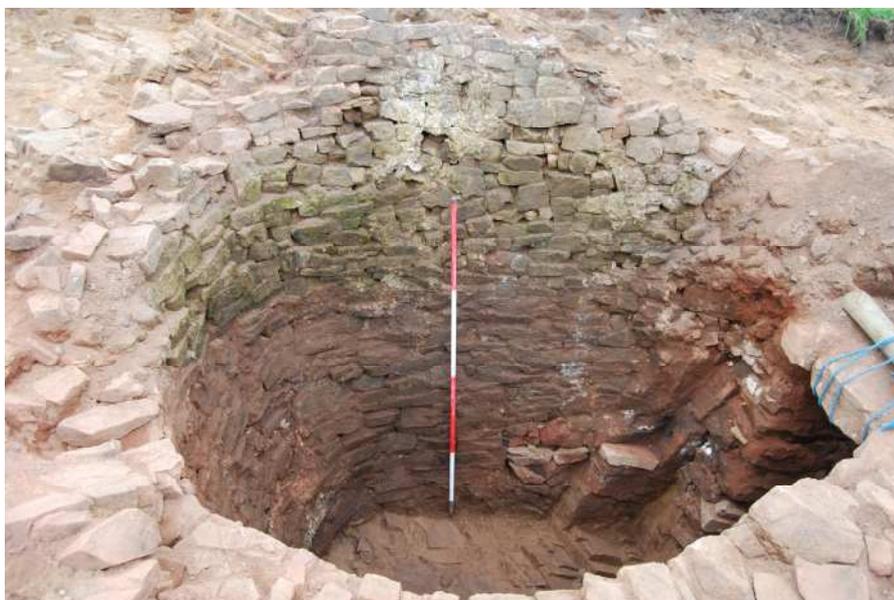
Figure 16. Photograph showing the southern half of the pot wall.

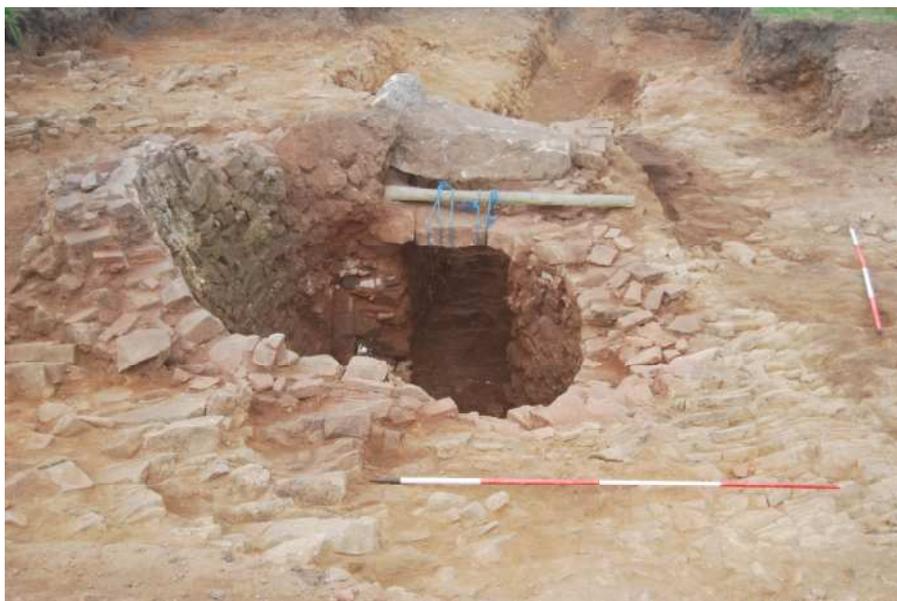
Figure 17. Photograph looking west showing the different levels to which the pot wall survives.

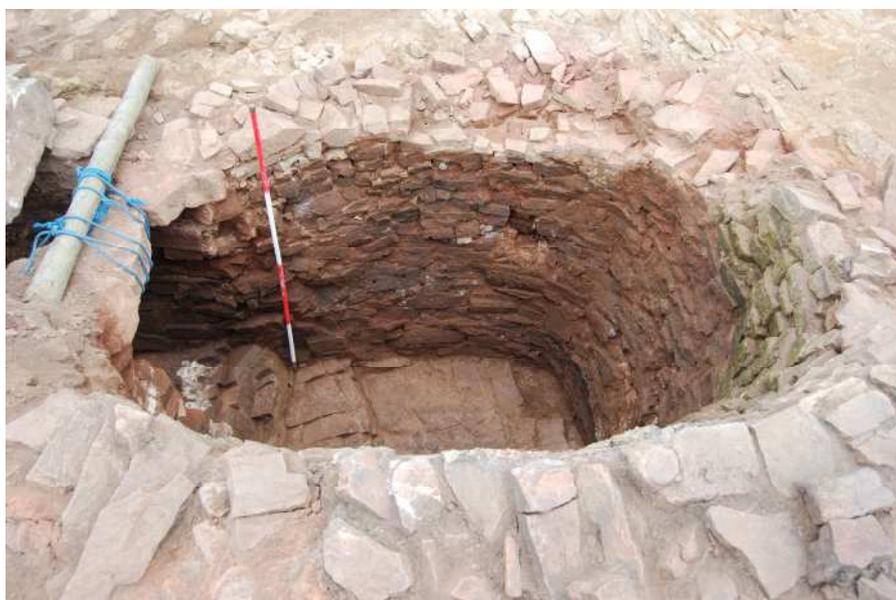
Figure 18. Picture showing the southern half of the pot wall.

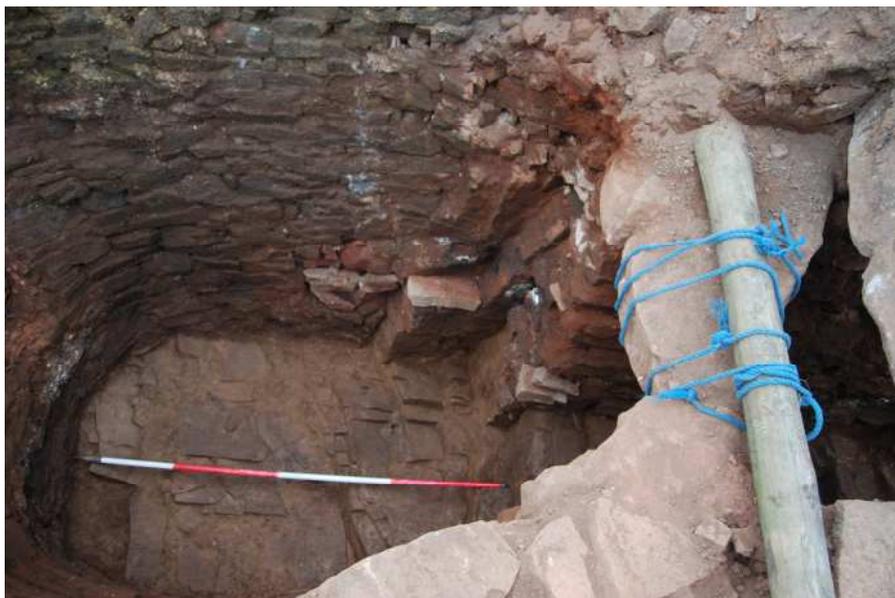
Figure 19. Photograph of the base of the Pot and what might be the remnants of a ledge used to support a grill.

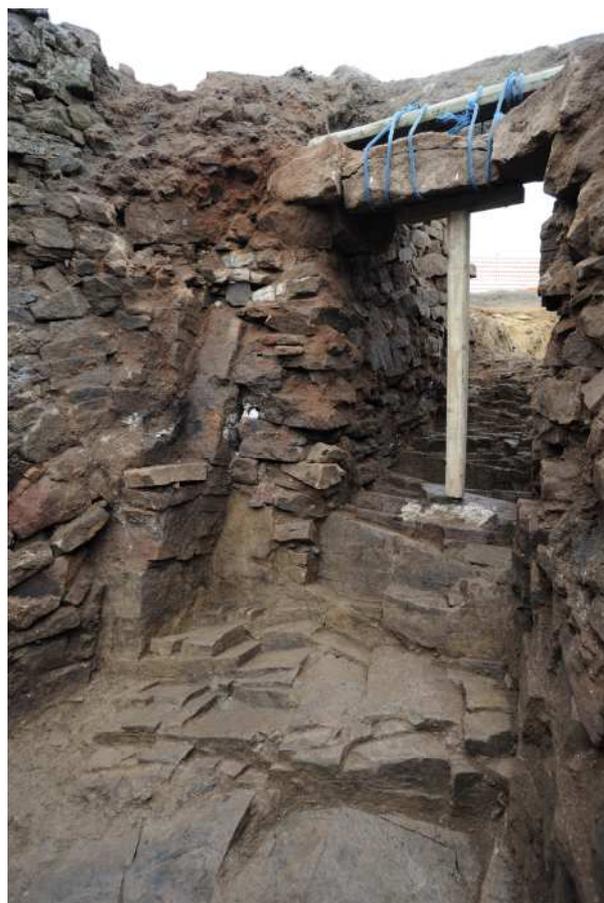
Figure 20. A picture of the internal opening of the Eye.

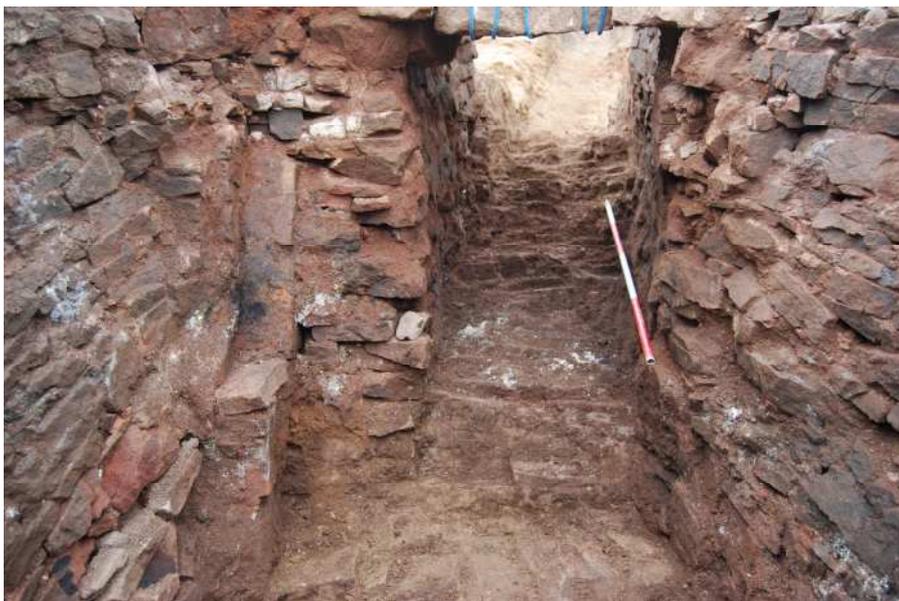
Figure 21. A view from inside the Pot looking through the Eye and along the flue.

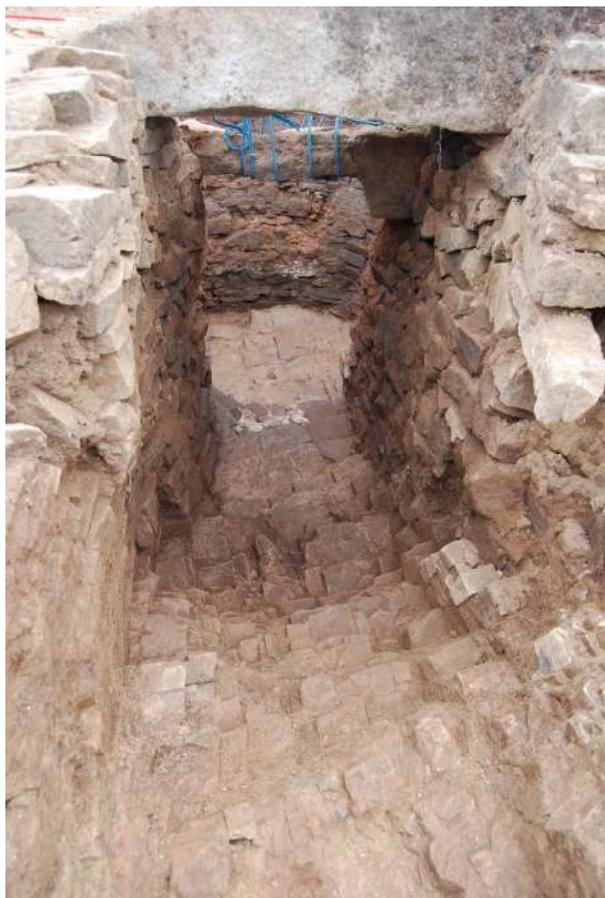
Figure 22. The opposite view; looking through the outside opening of the Eye, along the flue, into the Pot.

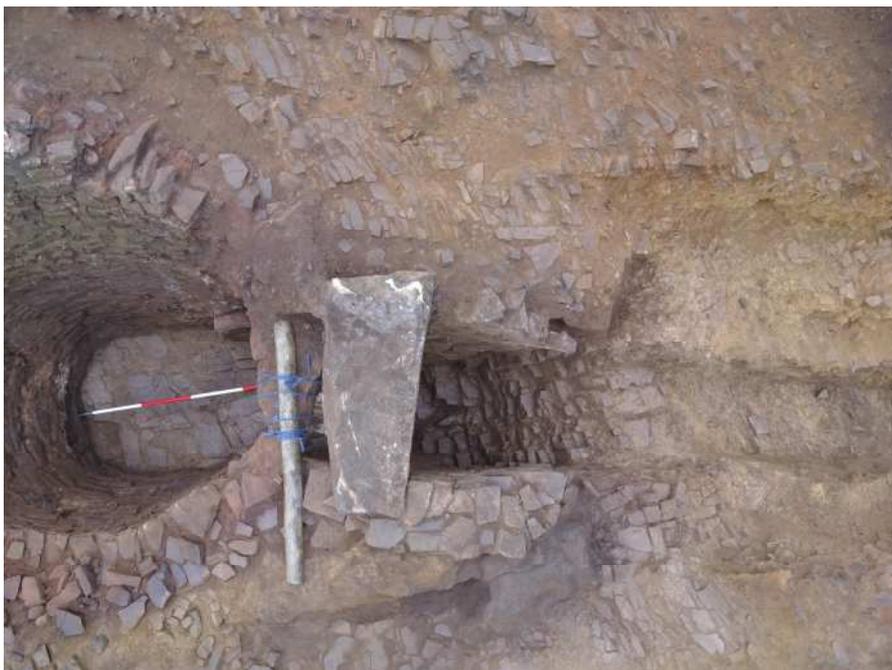
Figure 23. Aerial view of the flue and its flanking walls and two 'lintel' stones.

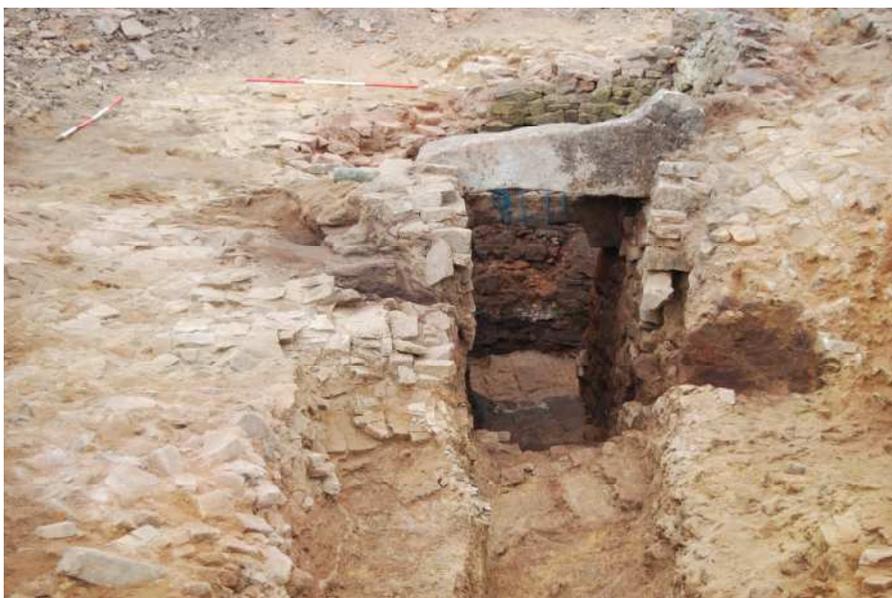
Figure 24. A view of the west end of the flue.

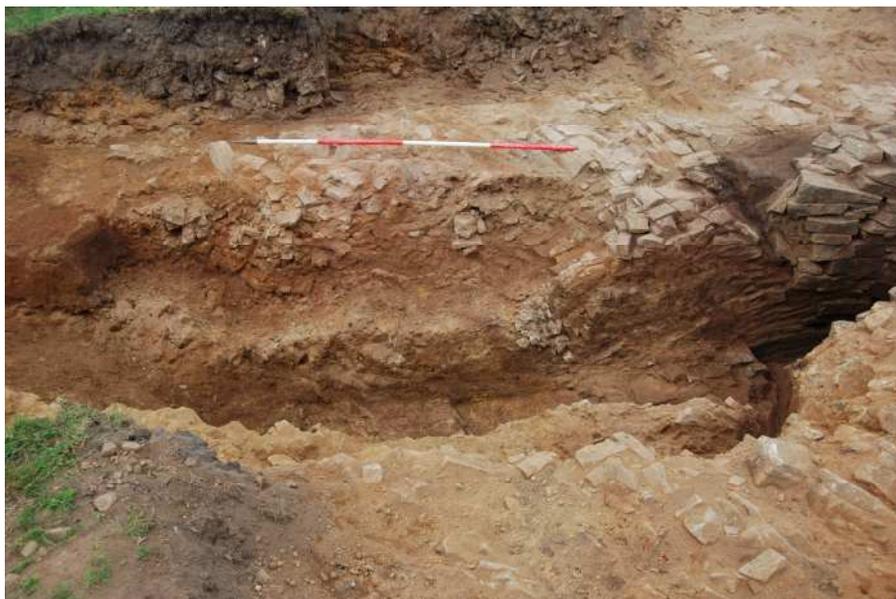
Figure 15 a view of the end of the flue looking north. The junction of the north flue wall and the natural, sloping bedrock can be seen. Immediately below the ranging rod is a layer of rubble presumably from the collapsed/demolition of the kiln. Below the rubble is what appears to be natural subsoil.

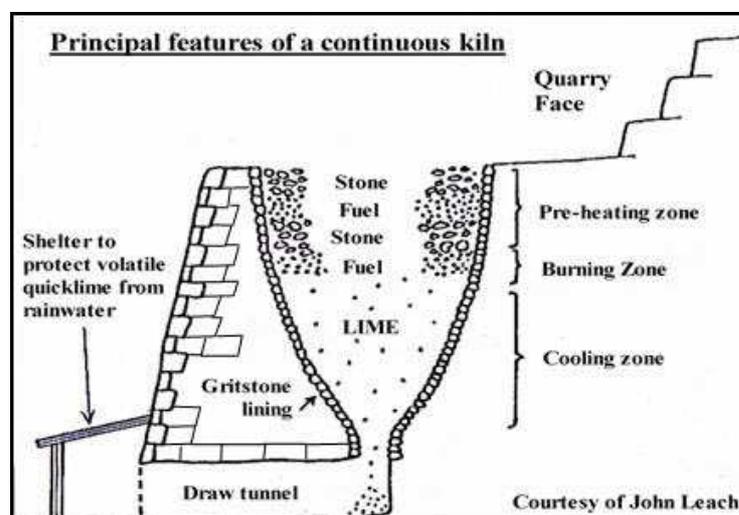
Figure 16 A schematic of a typical Field Kiln.

Field kilns such as the one at Knowle Farm fall into two basic types; flare kilns and draw or running kilns. The two have similar construction, generally a broad chimney, often set into the side of a hill. The kiln is loaded from the top (the hill side) and fired from the bottom, from whence the lime is also removed. Flare kilns are loaded with a single charge of limestone. Firstly a vault of limestone blocks is built over the furnace, above which the rest of the limestone is stacked. The fire is lit and kept stoked for several days until all the limestone has been calcined. The kiln is then unloaded, the lime sent to the slaking pits, and the process repeated with the next batch of limestone. In contrast, draw kilns have a permanent grate fixed over the furnace and the limestone is stacked above this in layers alternating with layers of fuel. As the fuel burns the limestone is calcined and the lime drops through the grate from where it is removed through the stoke hole. As the fuel/lime layers drop through the grate, further layers can be added at the top, allowing for a continuous process to be operated.

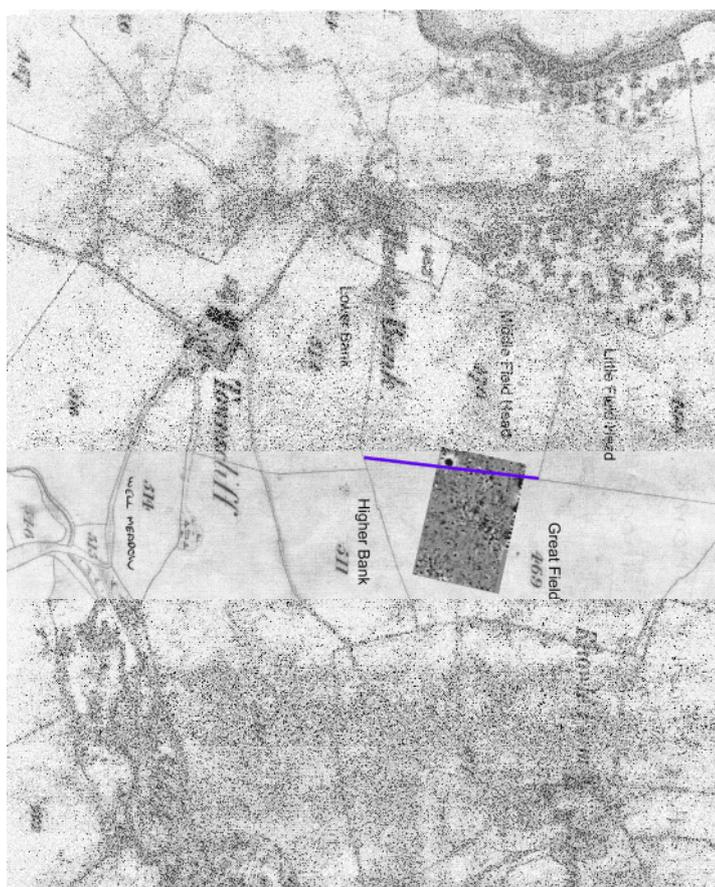
Figure 28. 1836 Measures and Values (Tithe) map turned through 90 degrees to orientate it with the Ordnance Survey map. The wall dividing Middle Field Head and Great Field has been highlighted in blue.

The 1836 map shows a field wall running east to west immediately to the south of the kiln site. Sometime before the Ordnance Survey map this wall has been removed in such a thorough manner that no trace of it showed up on the magnetometry survey. If the kiln was operating before 1836 then it was probably doing so in very close proximity to this dry stone wall. This is possible and stone from the wall during its demolition could have been used to help completely infill the kiln explaining why there was no tell tale depression in the modern landscape. However it is hard to conceive what the advantages would have been building the kiln so close to the wall while its presence must surely have hindered access to the kiln and the distribution of quicklime to the surrounding fields. It is possible that stone from the dismantling of the wall was used to supplement excavated rock in the construction of the kiln. The presence of what appears to be a stone gate post as part of the flue seems to support this idea. This would mean that the kiln operated sometime between 1836 and the 1880's.

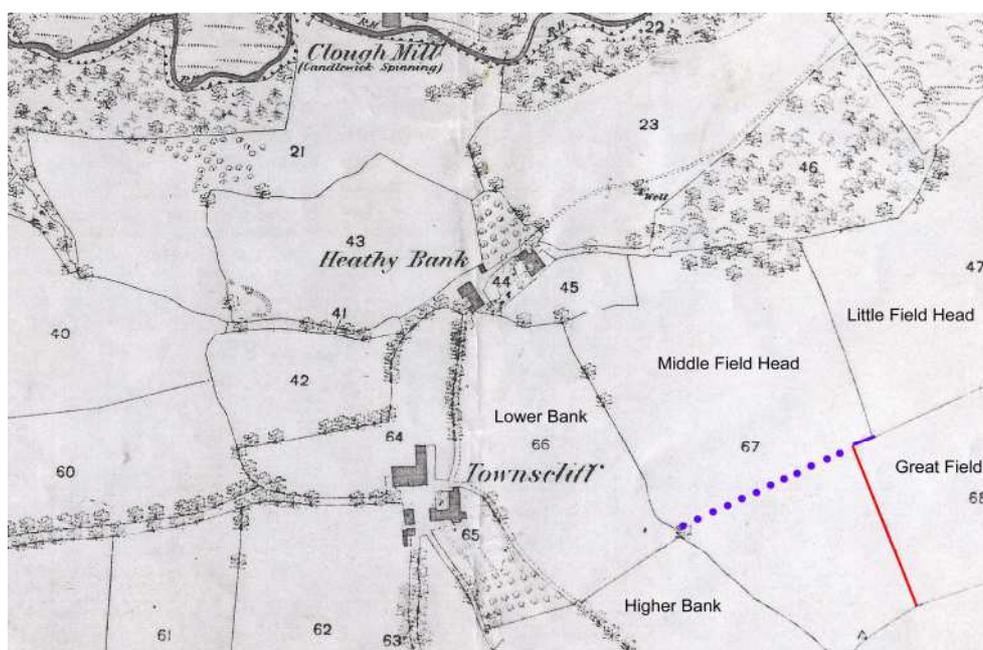
Figure 29. 1886 Ordnance Survey map. The old wall dividing Middle Field Head and Great Field has disappeared (its line marked with blue dots) and a new dividing wall built marked in red.
